NASA/TM—2005—212559

Debris/Ice/TPS Assessment and Integrated Photographic Analysis of Shuttle Mission STS-111

Author Name: Armando Oliu

June 2005

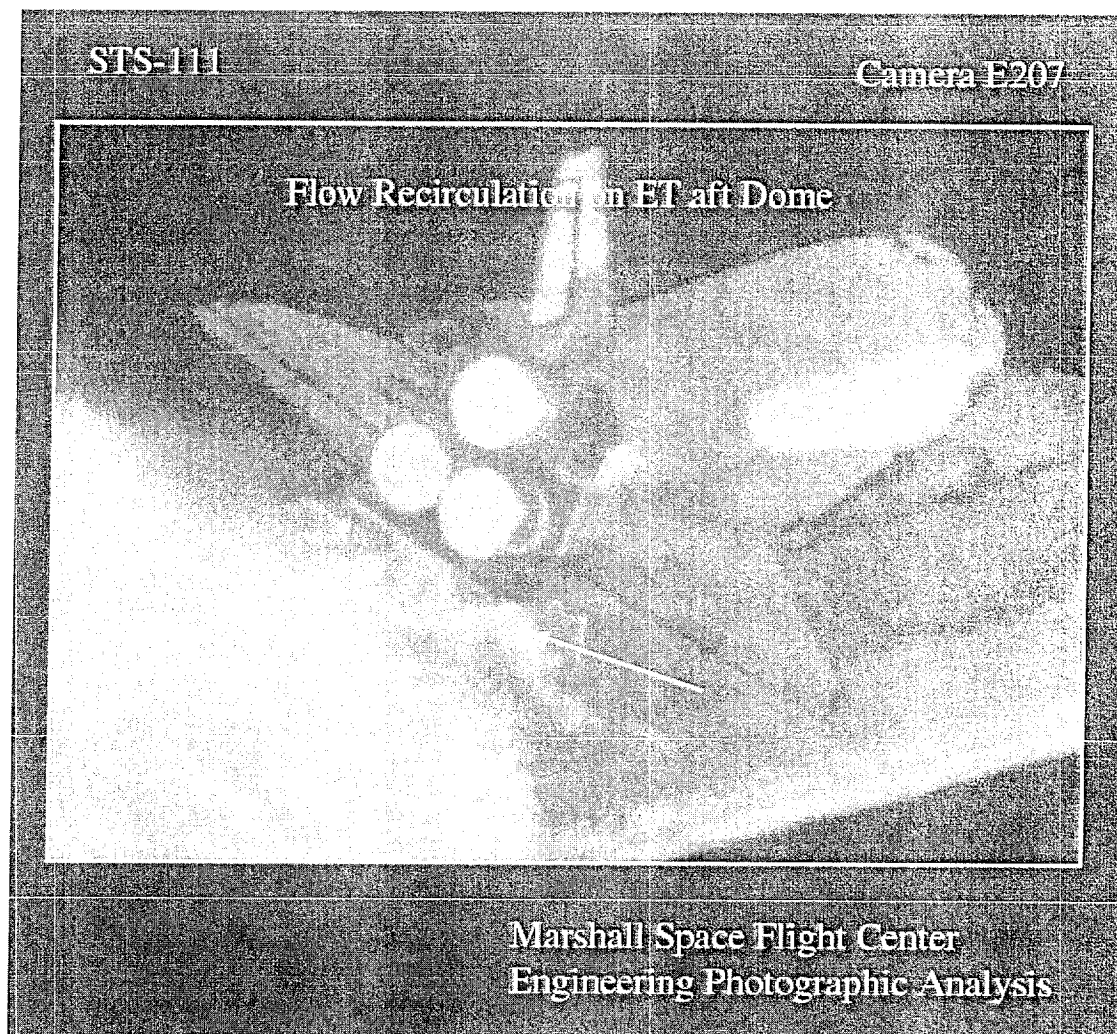
Figure 28. E207: Flow Recirculation

Film Camera E207: Flow Recirculation

Flow recirculation was observed during ascent.

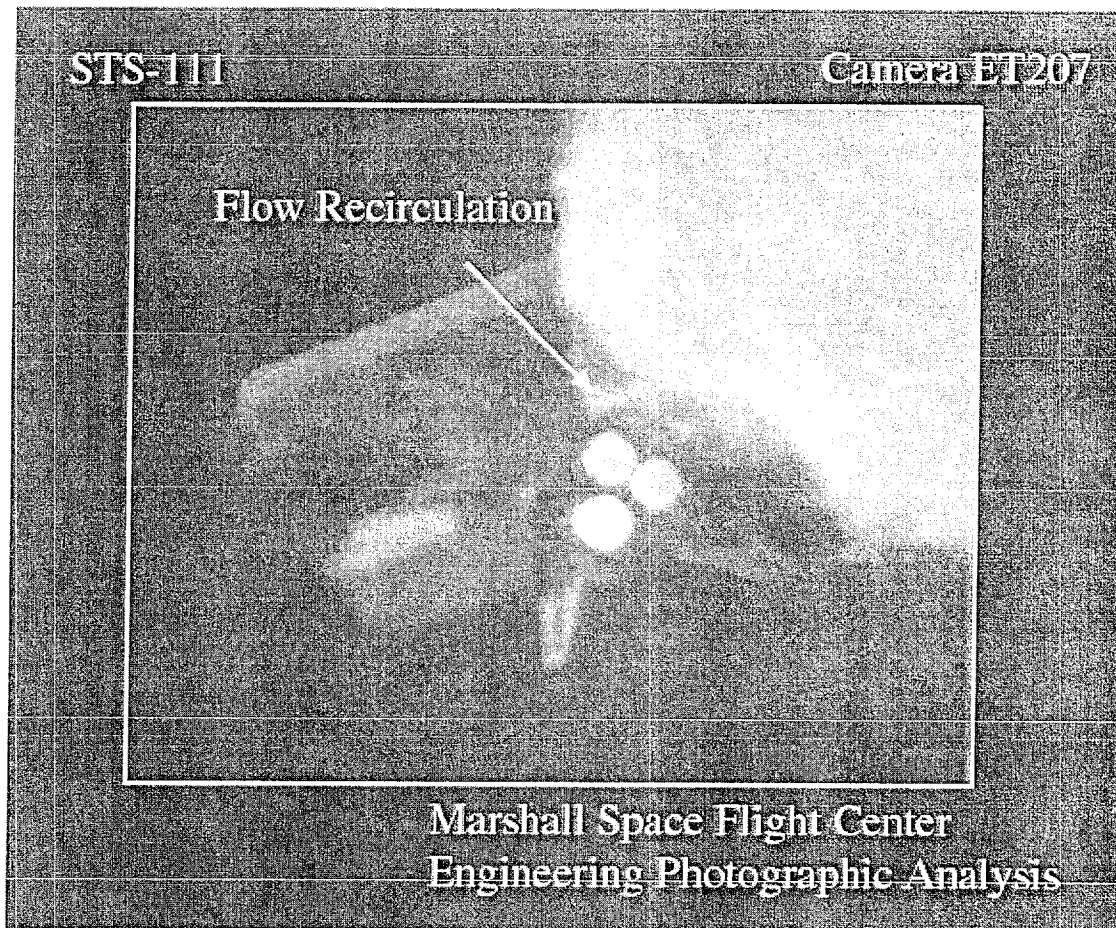
Figure 29. ET207: Flow Recirculation

Video Camera ET207: Flow Recirculation

Flow recirculation was observed during ascent.

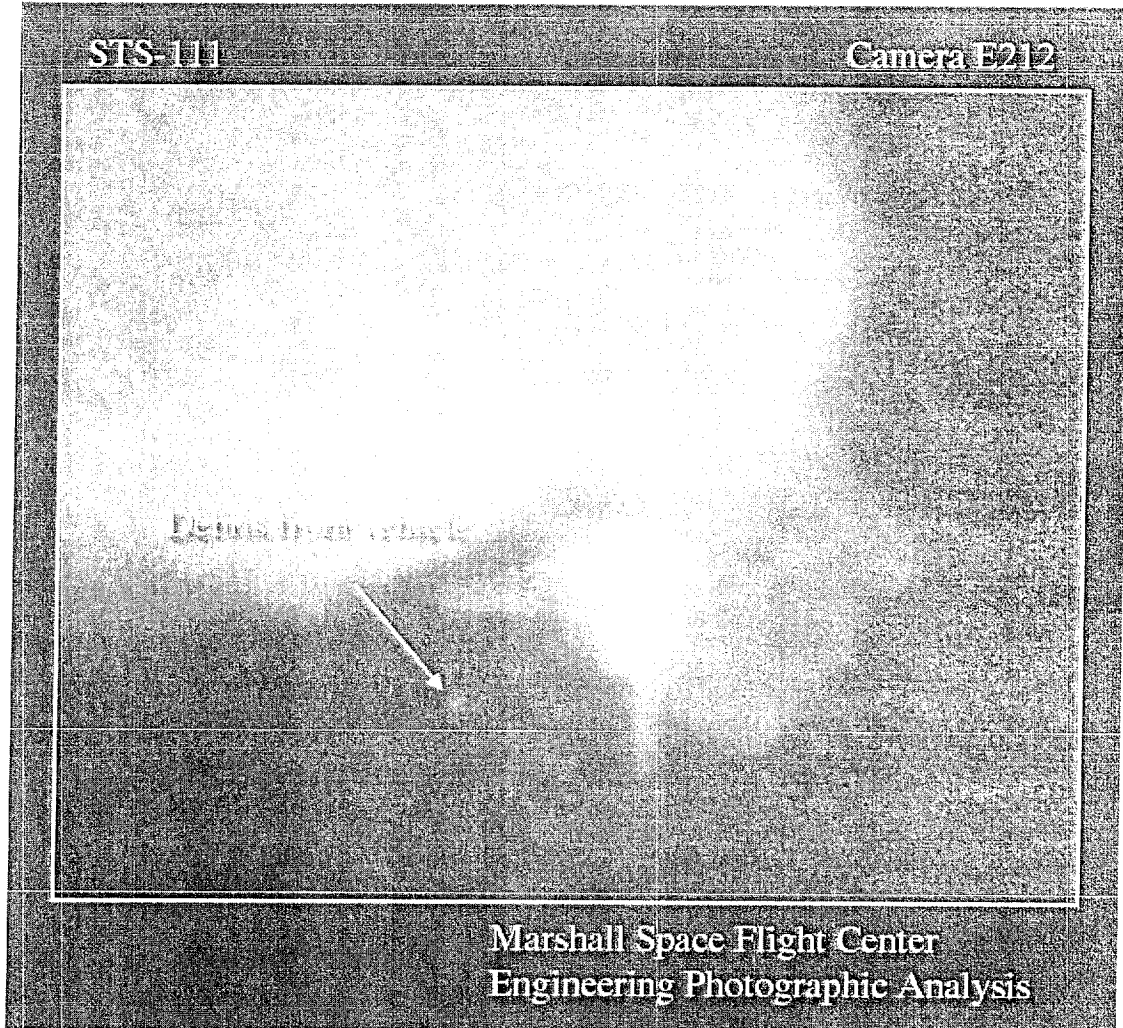
Figure 30. E212: Debris Falling Aft

Film Camera E212: Debris Falling Aft

Debris was observed falling aft of the vehicle during ascent.

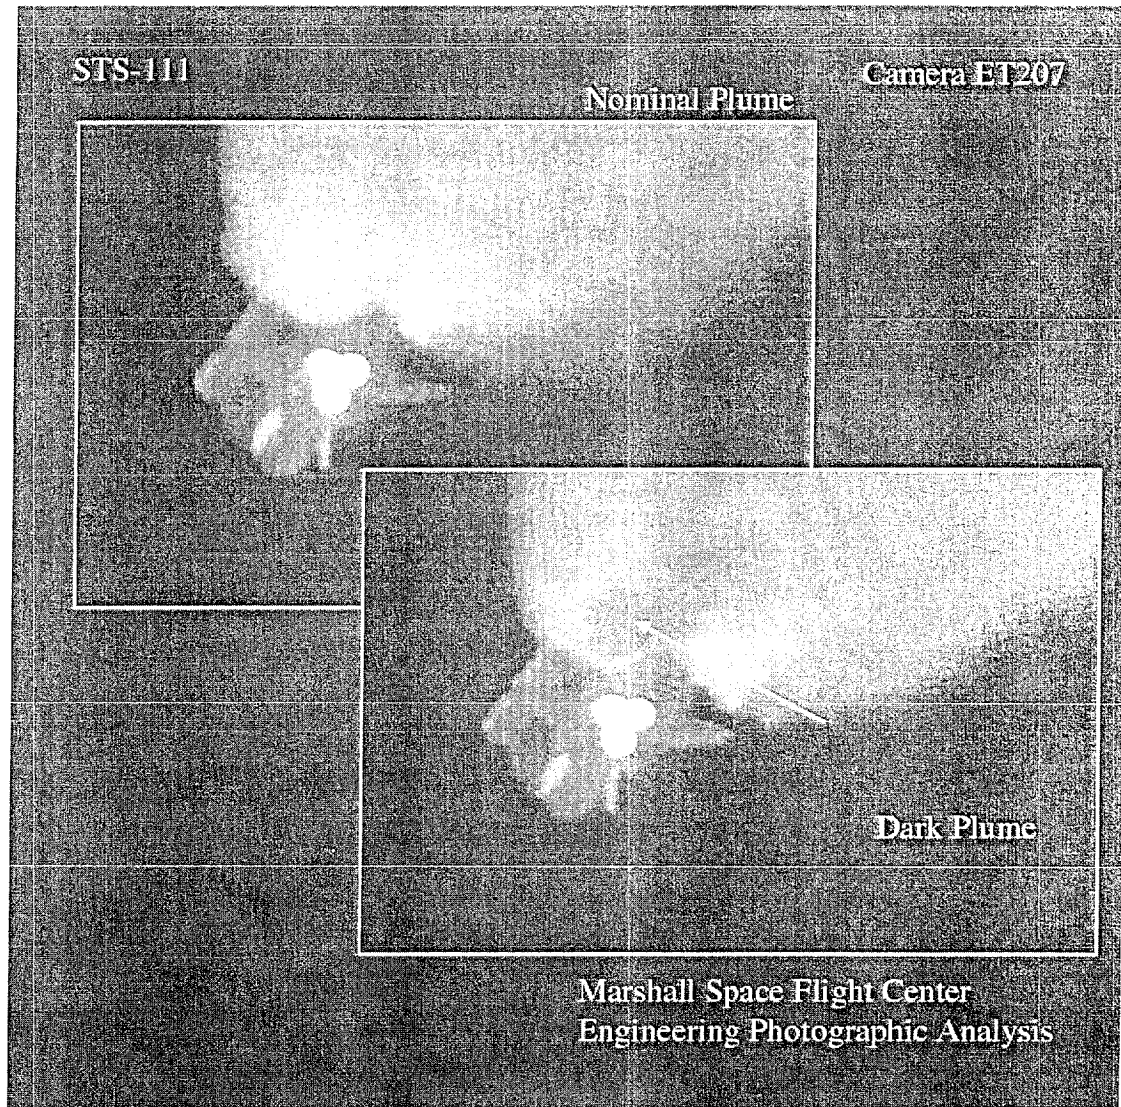
Figure 32. ET207: Dark Plume Event

Three separate events in which dark areas appeared in the SRB plumes were observed. The events were timed at 156:21:24:42.348, 156:21:24:42.548, and 156:21:24:42.681 UTC.

Video Camera ET207: Dark Plume Event

A closer view of one plume darkening and a comparison to a normal plume in this time frame is shown in Figure 32.

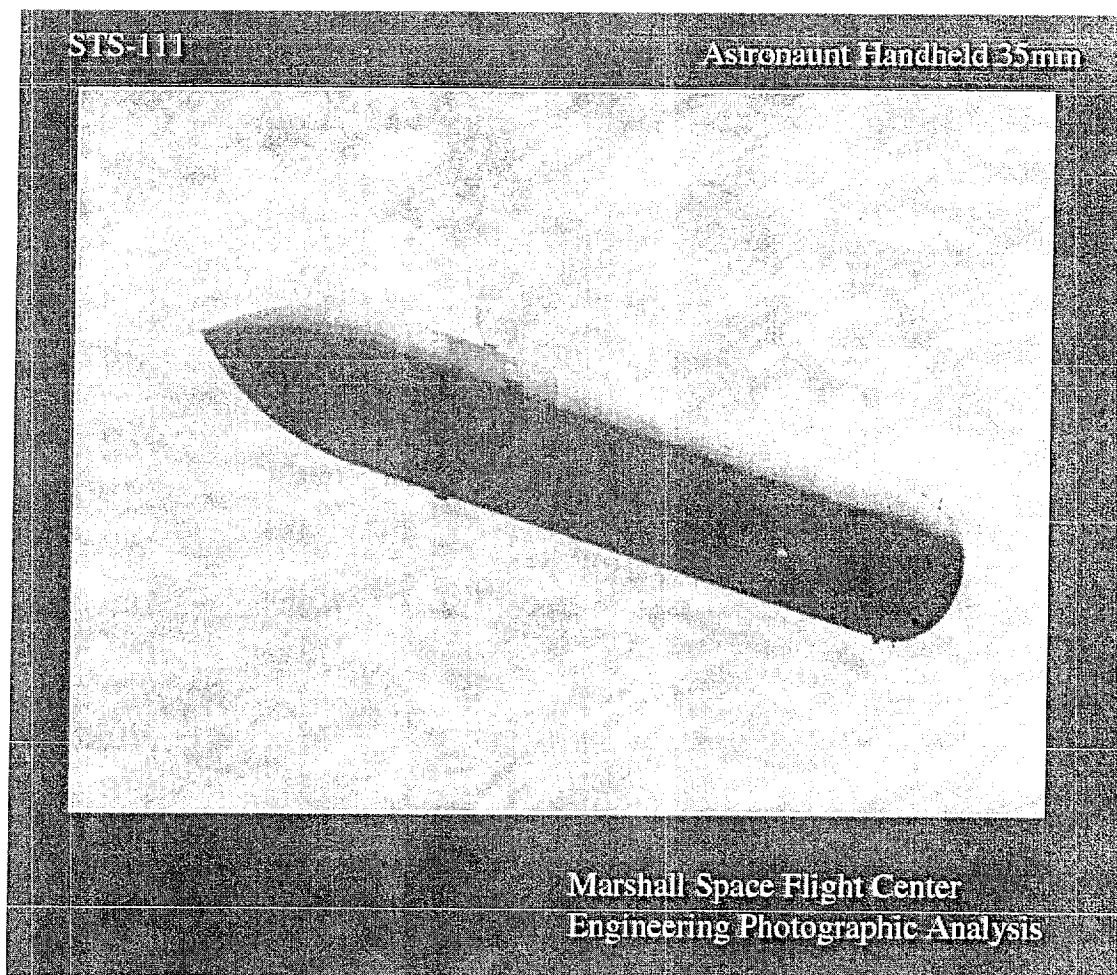
Figure 34. HH35mm: External Tank -Z and -Y Side TPS

Astronaut Handheld 35mm Still Camera: External Tank -Z and -Y Side TPS

The condition of the TPS visible on the -Y and -Z side of the External Tank appeared nominal.

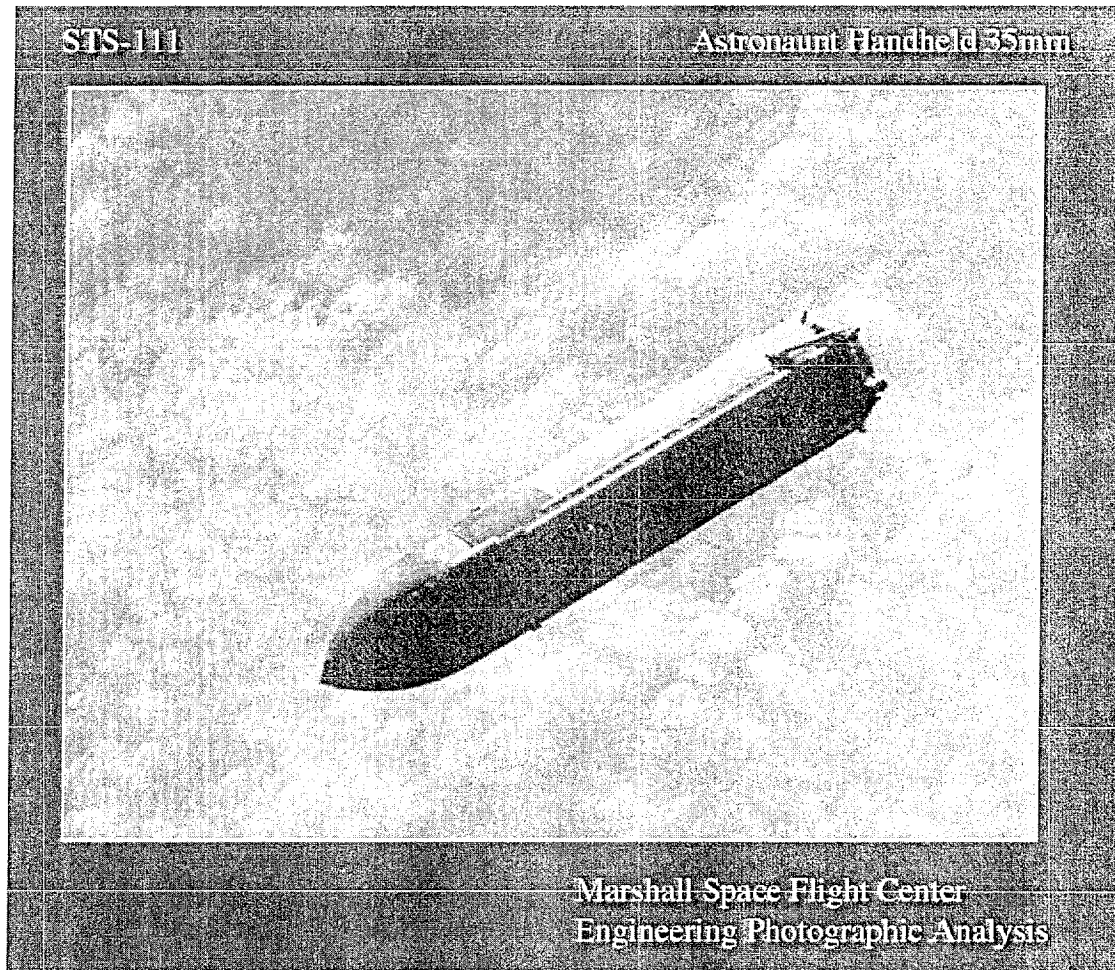
Figure 33. HH35mm: External Tank +Y and +Z Side TPS

Astronaut Handheld 35mm Still Camera: External Tank +Y and +Z Side TPS

The condition of the TPS visible on the +Y and +Z side of the External Tank appeared nominal.

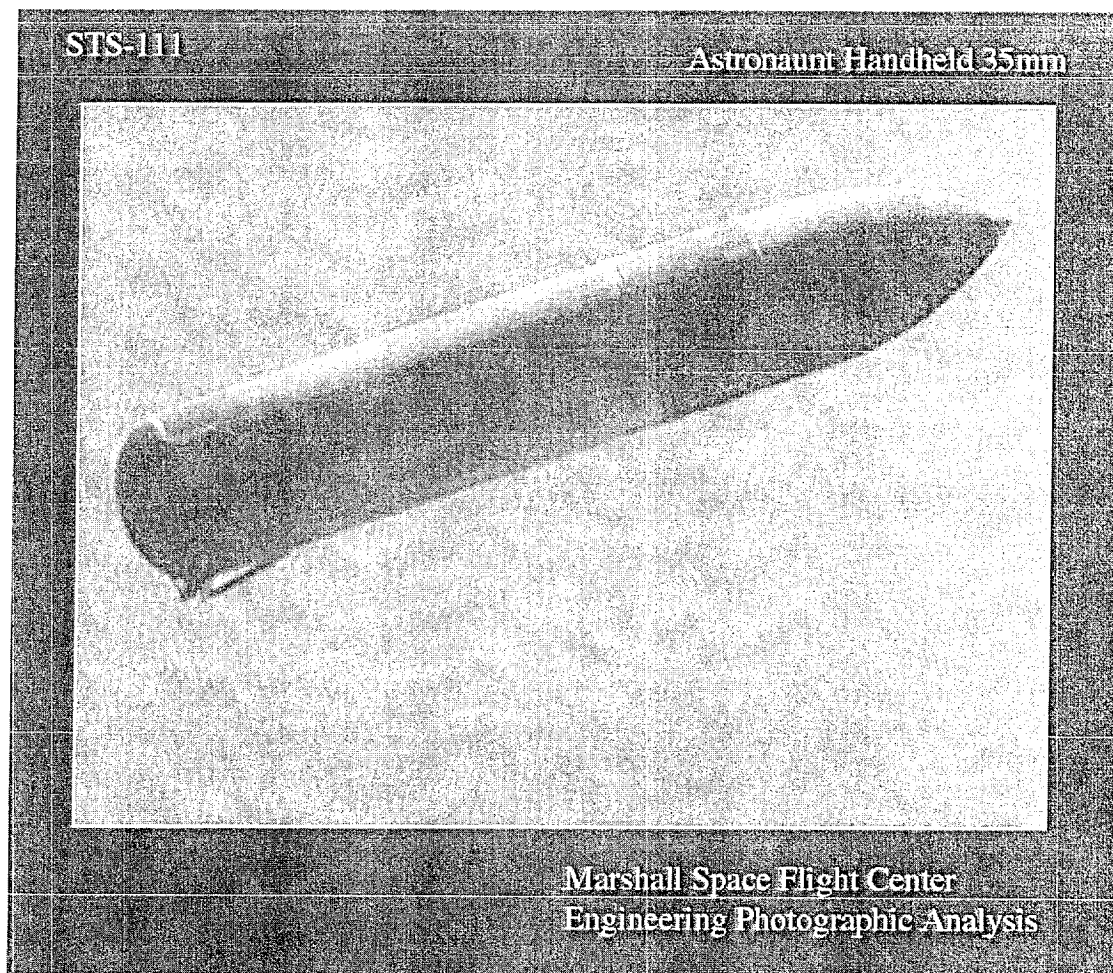
Figure 35. HH35mm: External Tank -Z and -Y Side TPS

Astronaut Handheld 35mm Still Camera: External Tank -Z and -Y Side TPS

The condition of the TPS visible on the +Y and -Z side of the External Tank appeared nominal.

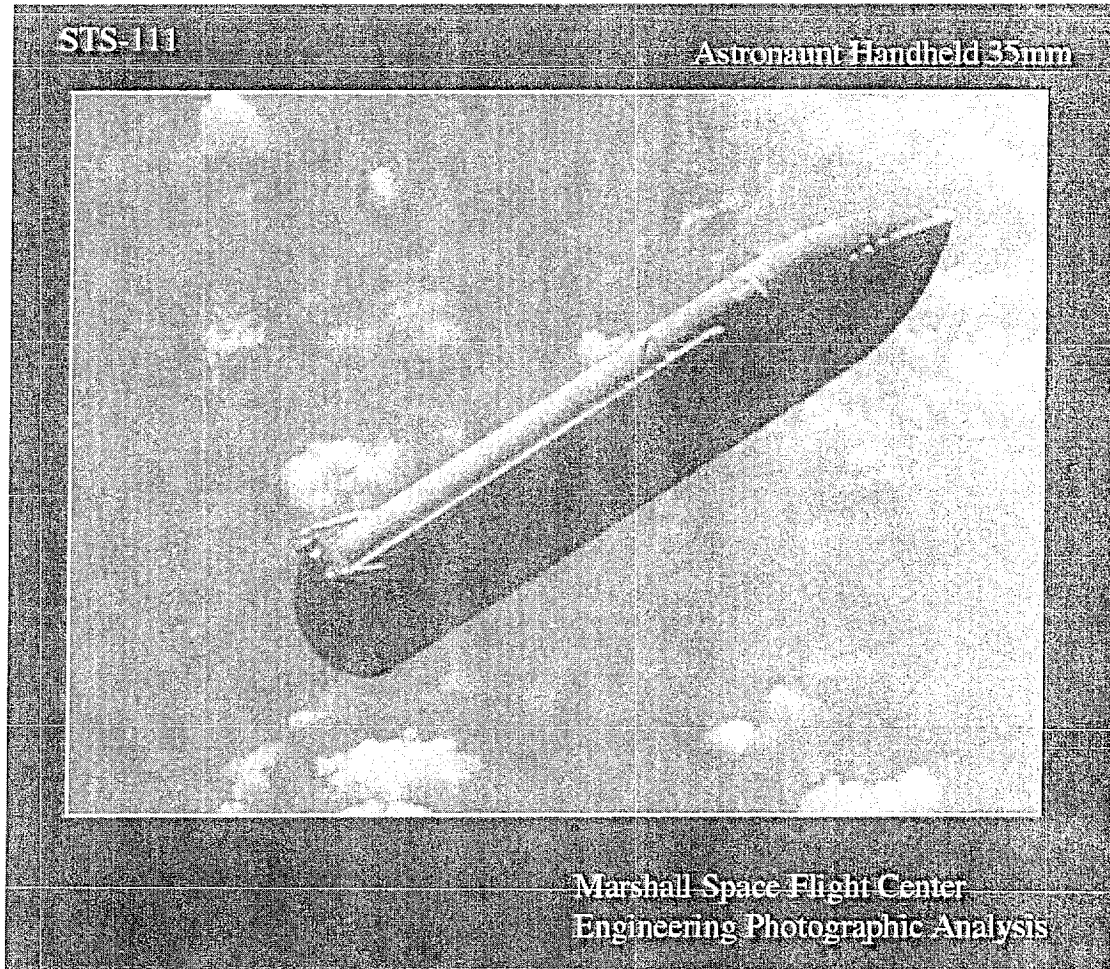
Figure 36. HH35mm: External Tank +Z Side TPS

Astronaut Handheld 35mm Still Camera: External Tank +Z Side TPS

The condition of the TPS visible on the +Z side of the External Tank appeared nominal.

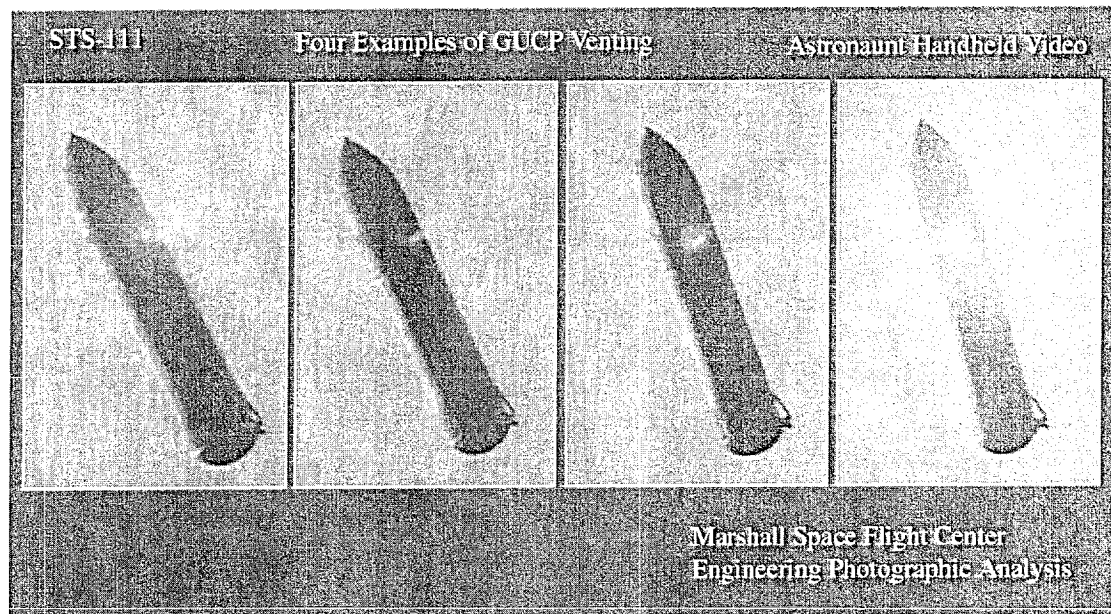
Figure 37. HHVideo: Venting from GUCP after ET/Orbiter Separation

Astronaut Handheld Video Camera: Venting from GUCP after ET/Orbiter Separation

Venting from GUCP was noted after ET/Orbiter separation. Good examples of this venting are illustrated in Figure 37. Venting from the GUCP has been seen on previous missions.

Although fine details could not be discerned, the general condition of TPS appeared good in imagery from the Astronaut Handheld Video camera.

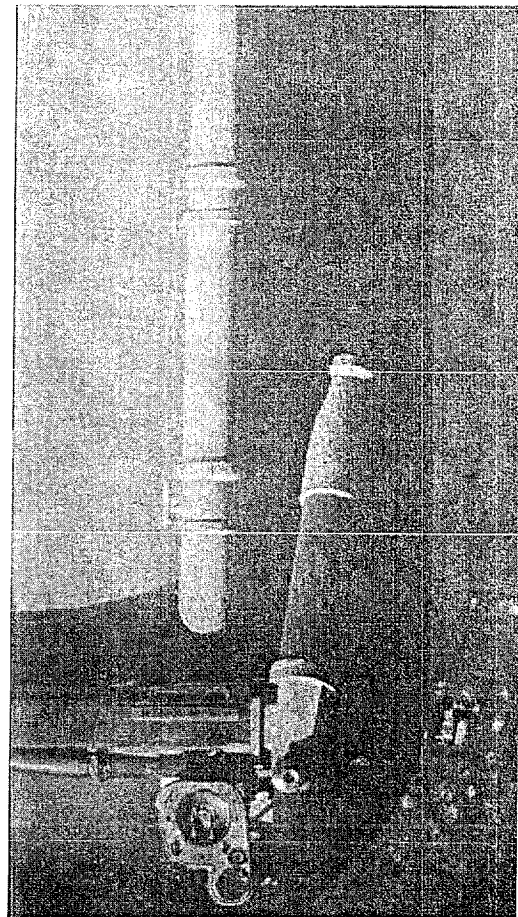
Figure 39 UMB35mm: Frame 20

TPS loss was typical. Normal popcorning and divoting of the aft dome, Figure 38. Typical TPS missing from thrust strut and LO2 feedline, Figure 38 and Figure 39. Divot noted on thrust strut, Figure 38. Three small divots noted, two under and one on the +Y side, near the bipod, Figure 41. One divot on intertank noted near forward -Y side of the LO2 feedline, Figure 43. Nosecap appeared nominal, Figure 44. The purge seal was noted in place around the EO3 joint, Figure 38. Glare from within EO3 joint bore observed, probably a reflection from the chamfer of EO3 bolt, Figure 38. A small positive yaw angle noted as ET moves away from Orbiter is noticeable through the sequence of frames.
